**DEPARTMENT OF TRANSPORTATION****DIVISION OF ENGINEERING SERVICES**

Contract #: 04-0120F4Cty: SF/ALA Rte: 80 PM: 13.2/13.9File #: 69.28**WELDING INSPECTION REPORT****Resident Engineer:** Pursell, Gary**Address:** 333 Burma Road**City:** Oakland, CA 94607**Report No:** WIR-000966**Date Inspected:** 28-Nov-2007**Project Name:** SAS Superstructure**OSM Arrival Time:** 730**Prime Contractor:** American Bridge/Fluor Enterprises, a JV**OSM Departure Time:** 1500**Contractor:** Zhenhua Port Machinery Company, Ltd (ZPMC), Changxing Island **Location:** Shanghai, China**CWI Name:** See Below**CWI Present:** Yes No**Inspected CWI report:** Yes No N/A**Rod Oven in Use:** Yes No N/A**Electrode to specification:** Yes No N/A**Weld Procedures Followed:** Yes No N/A**Qualified Welders:** Yes No N/A**Verified Joint Fit-up:** Yes No N/A**Approved Drawings:** Yes No N/A**Approved WPS:** Yes No N/A**Delayed / Cancelled:** Yes No N/A**Bridge No:** 34-0006**Component:** 89M Tower Mock Up & OBG**Summary of Items Observed:**

89M Tower Mock Up:

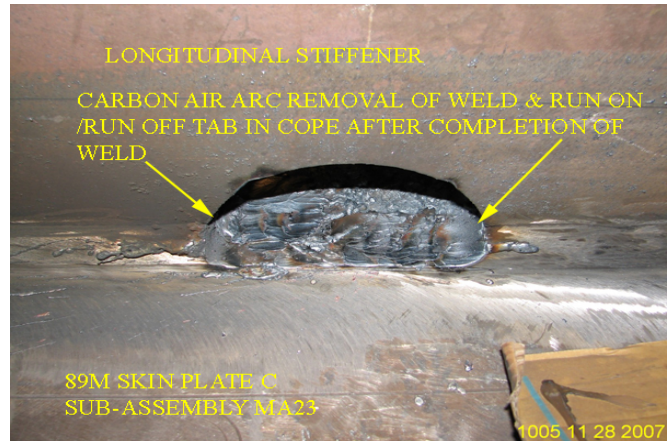
The QA Inspector randomly observed ZPMC welding personnel utilizing the carbon air arc gouging process to remove the run on/run off tabs from the copes in the longitudinal stiffeners on Skin Plate C, Sub-Assembly MA23. The attached photograph provides additional detail.
